Message from the president re the resurfacing agenda item (proxy item #2):

WHY RESURFACE OUR POOL NOW?

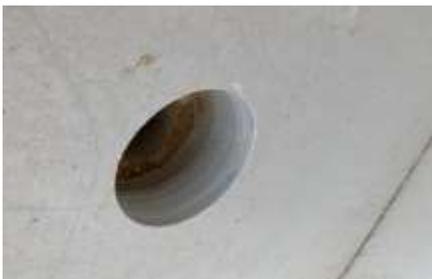
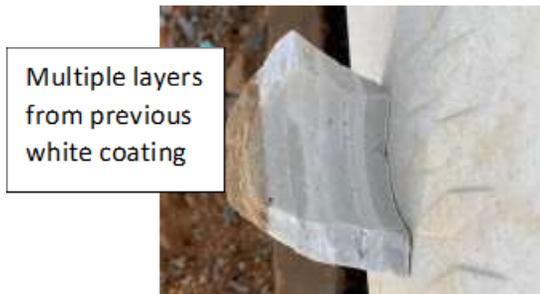
Resurfacing and white coating are different. White coating shouldn't be done more than 4-5 times otherwise the white coat will disintegrate more quickly if there are more than 4-5 layers. The photos below show PHRA's pool has seven layers, which contributed to the quicker failure of the last white coat. Ideally resurfacing should last 30-40 years if it's managed properly. We have received multiple quotes for the work and the previous board was looking into doing this a couple of years ago. The current board agreed unanimously it needs to be done now in order to protect our largest asset- the pool. And we recommend an assessment to pay for it; this will allow us to continue building back our reserves from the 2020 season. We have recouped some of those reserves this season but not all.

WHY: The plaster is peeling along the steps and floor of the pool. The pool industry refers to this as spalling. Our pool also has a large amount of check cracks, which are harder to see. They can also be described as eggshell cracks or, as the pros call them, craze cracks. Lastly, we have larger cracks that have caused the rapid loss of tile and pool edge coping in several areas in the pool and pool deck. Once this happens, there is no proper way to repair it and recoating must be done. If not, there is a risk that moisture will seep below the coating and cause corrosion and ultimately a failure of the metal structure of the pool. This work was recommend two years ago but was deferred due to other needed repairs. The board unanimously agrees this work needs to be done before next pool season and recommended an assessment to pay for it.

WHY NOW: Depending on the quality of the previous job, white coating/plastering of a pool surface will last 5-10 years. The standard is to apply a new coating on top of the existing coating, until the amount of layers prohibit that, as is the case with our pool. As seen in the photo below, our pool has so many layers that the previous layers must be removed and the surface taken down to the gunite, which is the concrete base layer above the metal structure.

It is estimated that the job will take 5-6 weeks to complete and the board proposes to do this work during the off-season.
